# Repair/Replacement of Concrete Lined Irrigation Channels

## Case Study Pipeline Replacement Methods

Burdekin River Irrigation Area  
State Water Projects, Queensland

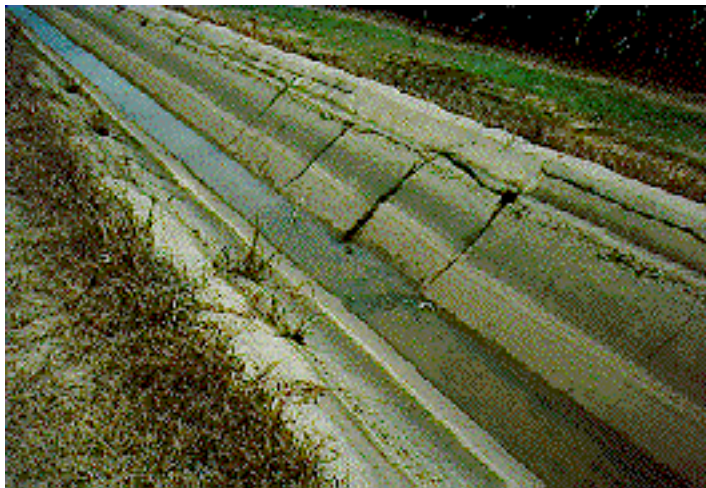
Channel A1 was constructed initially constructed in the late 1940's as part of a soldier settlement scheme growing principally irrigated tobacco. It was constructed of 50 mm thick unreinforced concrete cast as a series of slabs butting up against one another with no construction joint detail. The age of the concrete lining combined with the settlement between joints of the lining has led to sections of extensive cracking. In the past, sections of Channel A1 have been completely relined in concrete as recently as the 1980's.

A significant portion of the 3.4 kilometres of concrete lined channel has been constructed with the top section of lining being cast against fill as part of the channel banks. This fill material has settled over time, exacerbating the cracking problem. Infiltration of channel water beneath the lining has formed cavities which have led to areas of bank collapse.

**Figure 3 – Section of Concrete Lined Channel which slumped relative to adjacent section (note the detachment of capping from top of lining in right of photograph)**

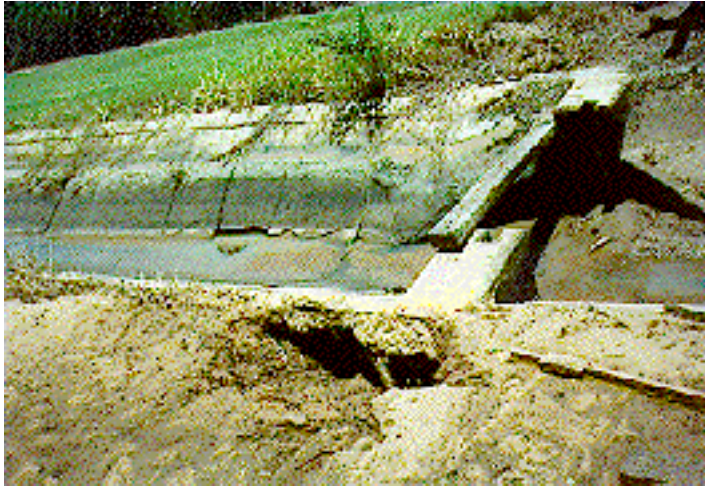
A further problem with Channel A1 is the inability to obtain the design flowrate for some dethridge wheel meter outlets. The infiltration of water through the concrete lining at the dethridge wheel has led to the slumping of the concrete work associated with the dethridge wheel emplacement. This has altered the sill level and consequently reduced the flowrate possible through the dethridge wheel (as well as inaccurate flow metering). This has resulted in the irrigator watering over longer periods which in turn has led to the delivery of water down the channel for longer periods resulting in increased infiltration and evaporation losses. The response to this problem has been to run some bays of Channel A1 full (ie with no freeboard). This has led on occasions to water overflowing over channel banks.

This water has then undermined the lining or channel structures. In the past, sections of channel have had a concrete capping added to try to increase the freeboard, but this concrete has tended to lift off the existing concrete lining leading to further infiltration and consequent undermining.

**Figure 4 – Undermining of a Check Structure  
(resulting in bypassing of flow)**
