Repair/Replacement of Concrete Lined Irrigation Channels

Case Study Geomembrane Lining

Mareeba Dimbullah Irrigation Area
State Water Projects, Queensland

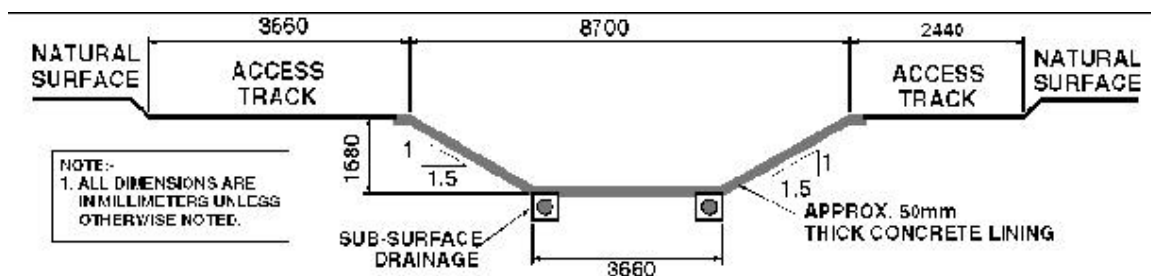
TYPE CROSS SECTION

The section of channel discussed in this paper crosses high permeability sandy soils and as such was originally concrete lined to limit water losses. The concrete is nominally 50mm thick and un-reinforced. Sub-surface drainage was installed in the bed of the channel, prior to the placement of the concrete lining so as to relieve any natural ground water and any minor channel leakage.

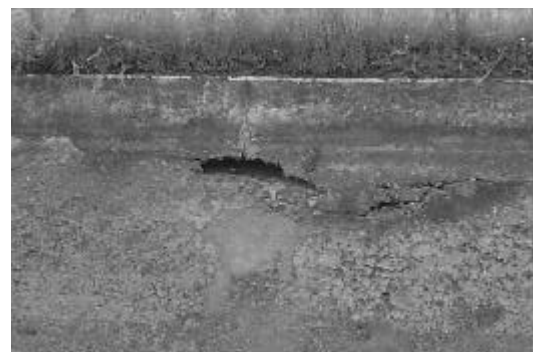
Constant seepage into the sub-surface drainage lines over many years has produced piping problems within the earthworks beneath the concrete lining. The resultant loss of integrity of the subgrade has resulted in significant joint displacement and cracking of the un-reinforced concrete lining. In some cases large voids have formed causing collapse of lining.
