# Repair/Replacement of Concrete Lined Irrigation Channels

## Case Study Pipeline Replacement Methods

Corbie-Merungle Hill Section of the  
Murrumbidgee Irrigation Area  
Leeton, New South Wales, Australia

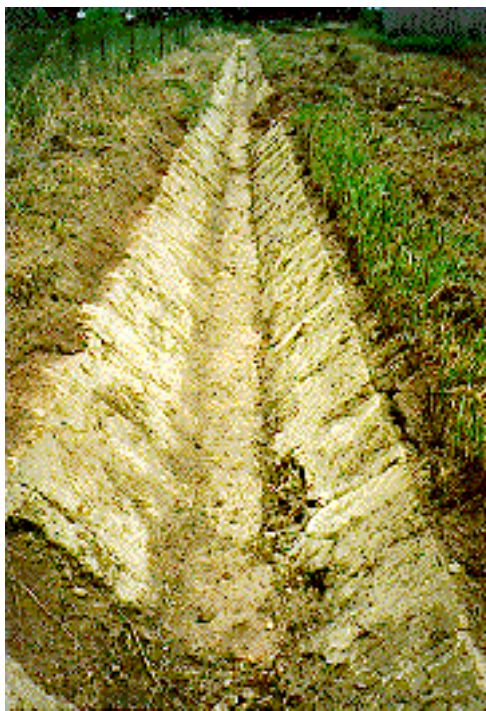
The major cause of problems with the concrete lining is its age and the method of construction. The concrete lined channels are over 70 years old and have deteriorated badly. The unreinforced nature of the gunite lining together with its relative thinness are also contributing factors. In a report by the Department of Water Resources in 1991 (Technical Services Division, January 1991) the following assessment was made of the concrete lined channel system : -

Condition	Life Expectancy (years)	Channel Length (% of total length)
Good	15	5
Fair	10	4
Poor	5	70
Bad	0	21

**Figure 3 – Typical Small Concrete Lined Channel (note channel deterioration)**

Thus it can be seen that approximately 90% of the channel system needed replacement within ten years. The response in the past has ranged from patching of the lining to complete relining as required. Brick topping has also been constructed along extensive lengths of the channel system in order to increase capacity as a consequence of flow restrictions through access and road culverts and increased demand.

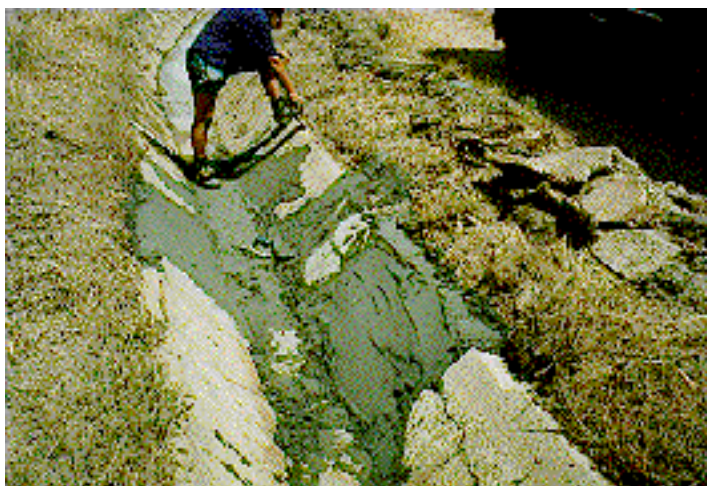
**Figure 4 – Mortar Patching of Concrete Channels**

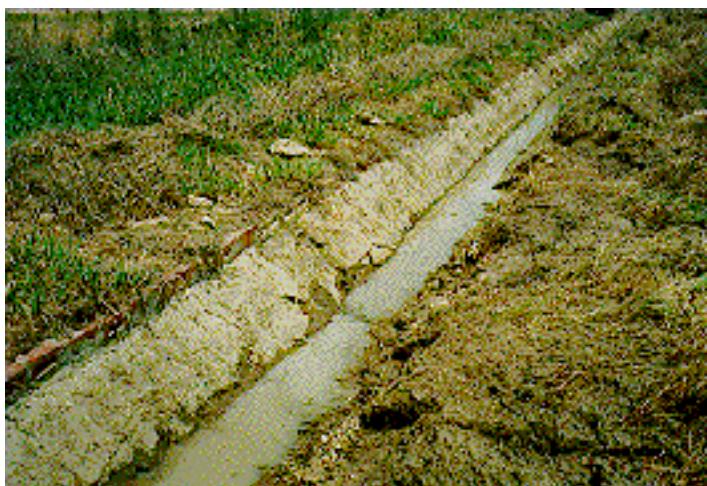
**Figure 5 – Brick Topping of Concrete Channels  
(on left hand side of photograph)**

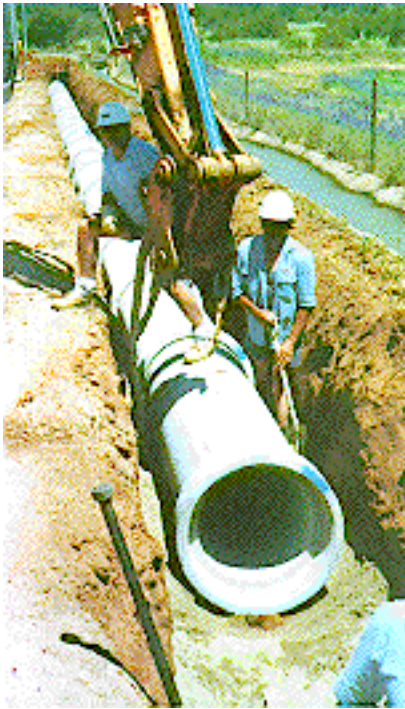
**Figure 5 – 600 mm diameter concrete pipes (RRJ) being laid as part of Line D replacement**

The lateral pipelines constructed to date have been exclusively rubber ring jointed concrete pressure pipe. This has been due to price especially for the larger diameters, especially for the larger diameters (> 300 mm). The pumping station for these laterals is now completed and commissioned and shall be in operation from next season for irrigation areas in Corbie Hill.
