Repair/Replacement of Concrete Lined Irrigation Channels

Case Study Channel Repair with Liquid Boot

California Aqueduct
Palmdale, California, USA

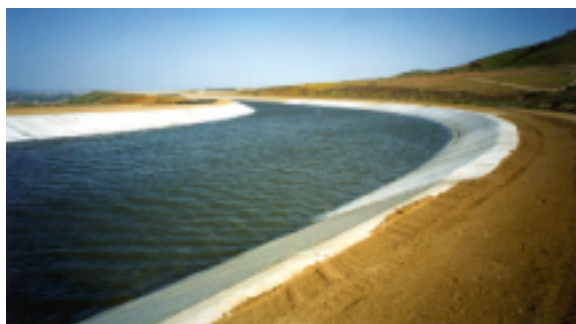
FIGURE 1

The California State Department of Water Resources, operates and maintains the California Aqueduct, one of the worlds largest gravity fed potable water channel systems, The Aqueduct is in excess of 1,000km long with only two transitory pump stations assisting flow over two mountain ranges. In the past the DWR has tried numerous systems when vital 'repair work' (ie. 320,000m²) was needed. Invariably, all these systems required that the channel be shut down for extensive periods.

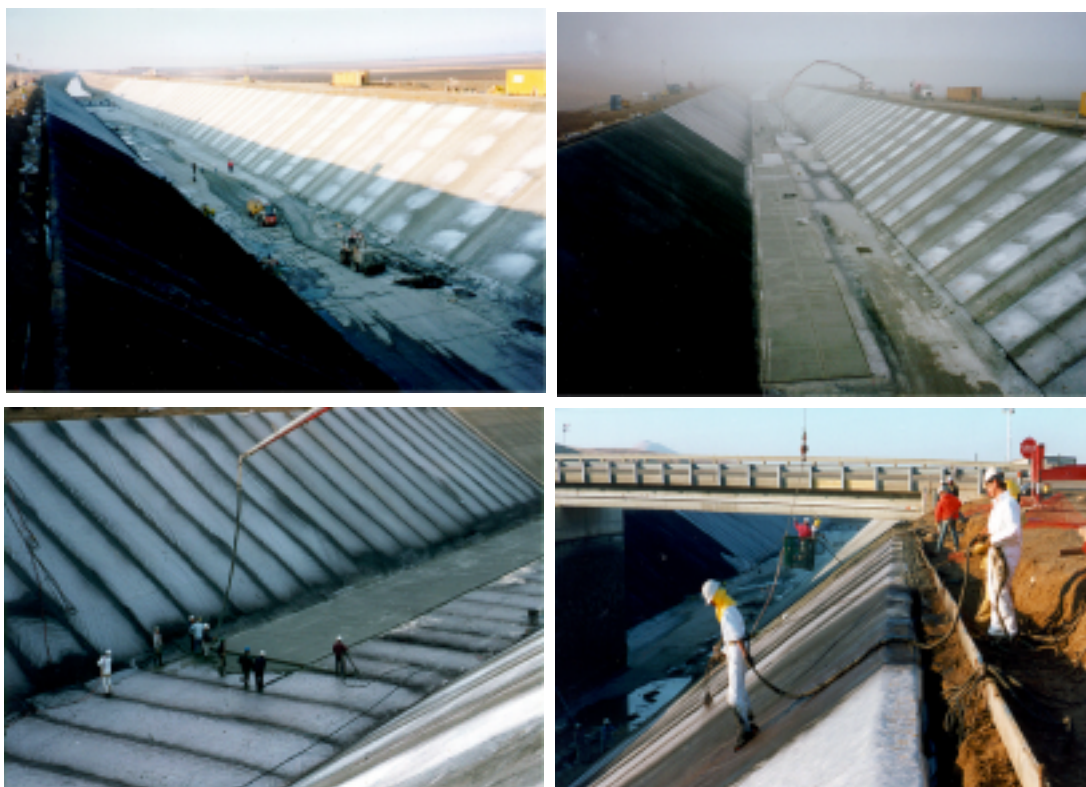
FIGURES 2-5

The canal was emptied between two Locks, which are located approximately every ten kilometres. Following emptying, the canal walls and invert were pressure washed to remove built up dirt and silt. A transverse ditch was saw cut 50m upstream and 50m downstream from the affected area as well as a conventional ditch at the top on each side of the canal to act as an anchor point for the geotextile fabric. The affected area was removed back to bare dirt and compacted to 90%, as this was being carried out a tack coat of “Liquid Boot” was spray applied over the entire surface area in liquid form, this allows the membrane to seal any smaller cracks in the concrete. Geotextile fabric in 4m wide rolls was placed over the surface area and into the transverse and side trenches. The geotextile acts as reinforcement for the membrane.

“Liquid Boot” was then spray applied by two teams of four applicators working around the clock, mostly in sleeting and below freezing conditions.

Immediately following the application of “Liquid Boot” a second layer of Geotextile fabric was placed over the membrane. The shotcrete crews commenced placing 50mm concrete wear course over the “Liquid Boot” membrane and concrete filled the trenches to anchor the membrane below the wear course.
