REPAIR/REPLACEMENT OPTIONS FOR CONCRETE LINED IRRIGATION CHANNELS

CASE STUDY

JOINT REPAIR WITH MOUNTAIN GROUT

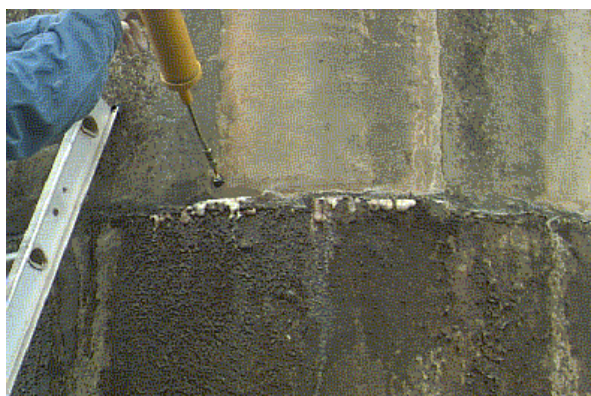
FIGURE 1

Several 16mm drill holes were bored at an angle of approximately 45° (Figure 1 and 2) through the leaking joint.

Once the holes were located in the correct position a disposable packer is inserted into the hole and secured using a self-sealing mechanism. The packer provides a seal against the inside of the hole each side of the joint and allows the mountain grout to be injected into the joint. In some cases the packers may be able to be reused once.

The material was then injected into the joint via a conventional pumping apparatus (grease gun) with an adaptor suitable to match the packer. The pump to be used to inject the material must be able to produce pressures in excess of 1750 kPa in order to bypass the in-built check valve in the packer.
