# REPAIR/REPLACEMENT OPTIONS FOR CONCRETE LINED IRRIGATION CHANNELS

## CASE STUDY

### JOINT REPAIR WITH PLASTIJOINT SEALANT

# Case Study – “Plastijoint” Flexible Sealant

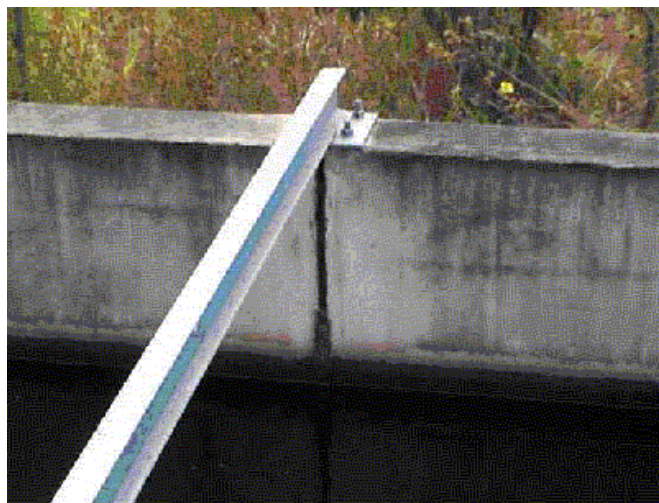
**FIGURE 1**

“Plastijoint” is heated to 50 –60°C by placing the can in boiling water for approximately 1 hour. When heated the material forms putty like consistency and can be pushed by hand into the exposed joint (see Figure 1). This material has a suitable consistency to bond to concrete surfaces on a vertical face. Care is taken to ensure that the sealant is well packed and all possible voids are filled.

All porous surfaces (eg. concrete, brickwork, timber etc.) need to be primed before application of the joint sealant. The primer is painted on to the joint faces and allowed to dry before application of “Plastijoint”. The primer is usually touch dry within 30 to 60 minutes of application, and must be sealed the same day it is applied. Where sealing cannot be completed on that day then a further coat of primer should be applied and sealed as noted above.

“Plastijoint” sets as it cools, however a 3 day consolidation period is recommended before refilling the channel.
