REPAIR/REPLACEMENT OPTIONS FOR CONCRETE LINED IRRIGATION CHANNELS

CASE STUDY

JOINT REPAIR WITH RUBBER INSERTION SEALS

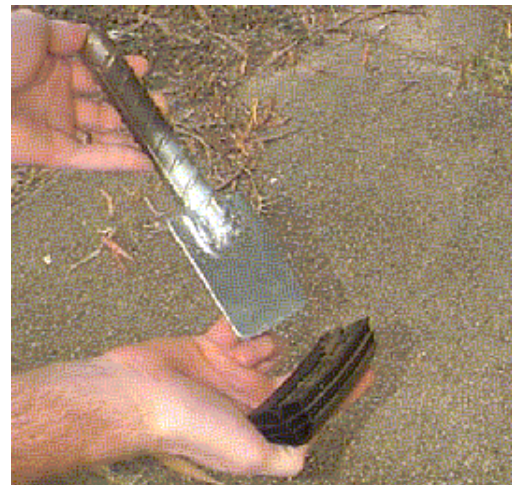
FIGURE 3

A self-sealing, pre-fabricated rubber insertion seal was then pushed into the exposed joint by hand with an insertion tool to hammer the seal home (Figure 3). Great care was taken to ensure that the rubber seal was embedded all the way to the bottom of the joint. Ideally there should be no part of the seal protruding from the joint once it is installed.

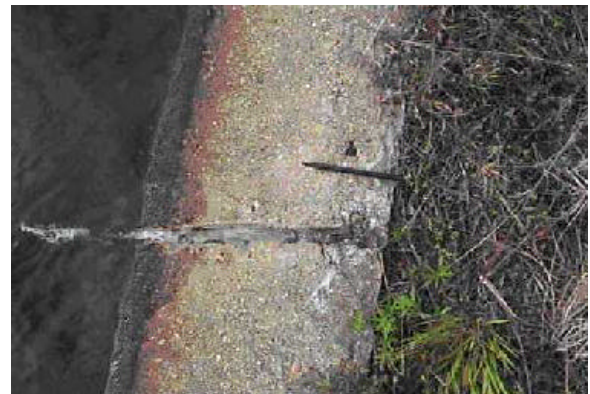
FIGURE 5

Step 6. A protective coating of bituminous paint (see Figure 5) was then placed over the rubber joint to protect it from weathering (primarily sunlight) and damage that could be caused during channel cleaning operations. The protective coating was not effective and soon peeled away.

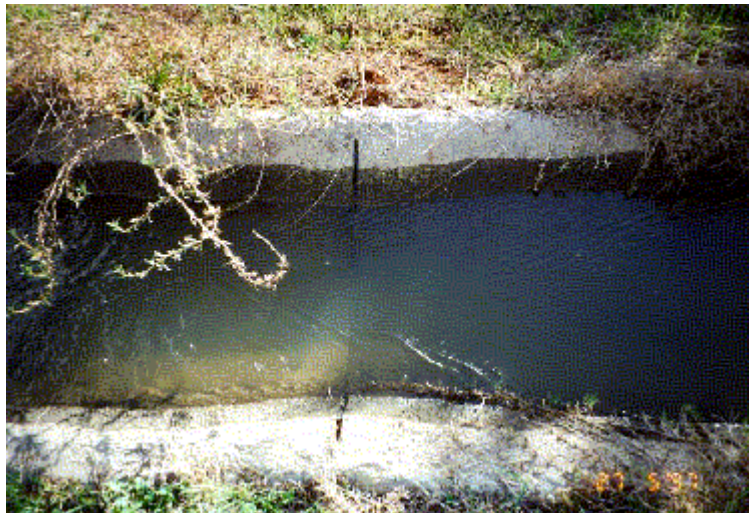
FIGURE 6

- In the future, joint faces may be re-faced using a self-propelled concrete saw with diamond blades (see Figure 5 for example of saw cut joint). The saw should have a gang mounted blade with the outside blades spaced to slightly enlarge the joint and remove all materials which adhere to the joint faces. The blade should be stiffened with dummy blades or washers. Immediately after cutting a high-pressure water jet should be used to remove all debris and mortar paste from the saw cuttings. This method has proven successful with similar repairs and would obviously provide an improved surface for the rubber seal to be inserted into.
