REPAIR/REPLACEMENT OPTIONS FOR CONCRETE LINED IRRIGATION CHANNELS

CASE STUDY

JOINT REPAIR WITH EMACO S90 (SEACRETE)

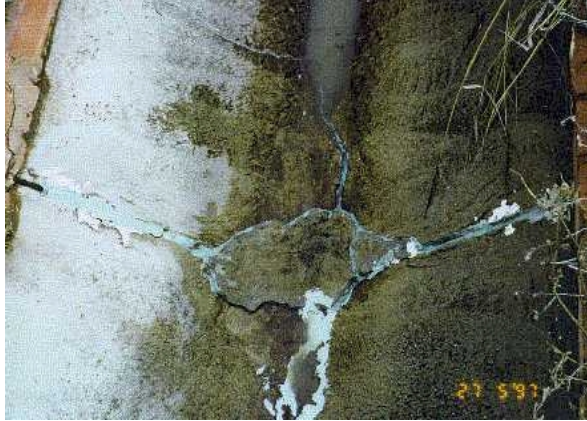
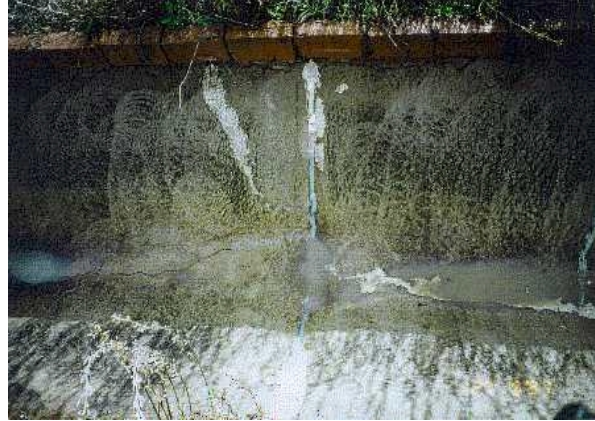
The problem of failing joints (and cracking) in concrete lined channels in the MIA is significant and directly contributes to loss of irrigation water and potential revenue. Primarily the damage to the channels has been caused by the gradual deterioration over many years (some channels in this area are over 60 years old). Many sections of channel are now drawing near to the end of their practical life. With this in mind it must be realised that any repair option has to be able to be carried out with a minimum of expense, otherwise complete channel replacement may prove to be the more viable option.

Figures 1 and 2 -Damaged channel with previously unsuccessful joint repair

- a. Complete replacement with new concrete lining
- b. Poly lining
- c. Spot patching and joint sealing using Emaco S90 rapid set mortar

It was decided that the channel potentially had enough useful years of service remaining to justify the use of option (c). This repair option would ensure several more years of service without the major capital expenditure required for options (a) and (b).

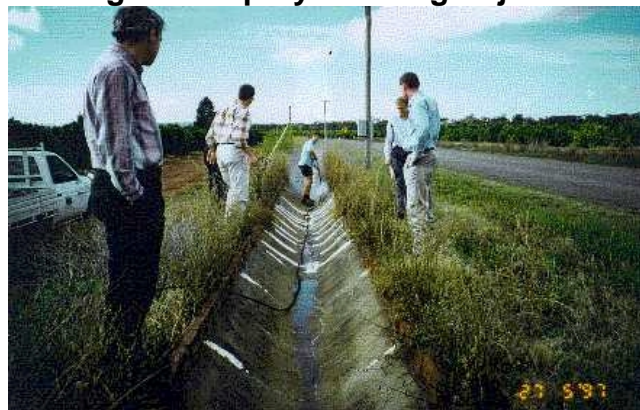
The surface of the existing lining and the interior of the joints were cleaned by water blasting with pressures of 4000 to 4500 psi. This water pressure proved adequate to remove sufficient unwanted material from the joint/crack cavity.

Figure 3 -Spray cleaning of joints

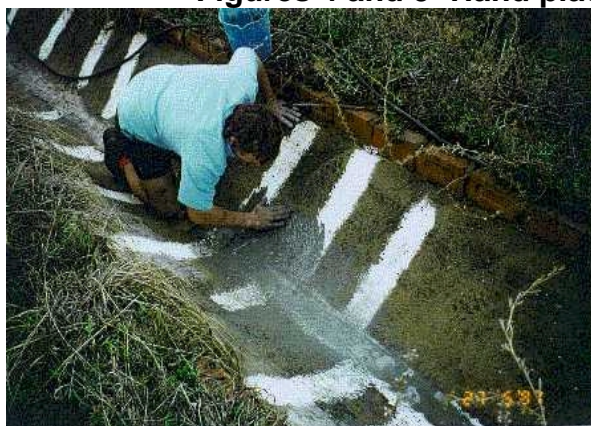
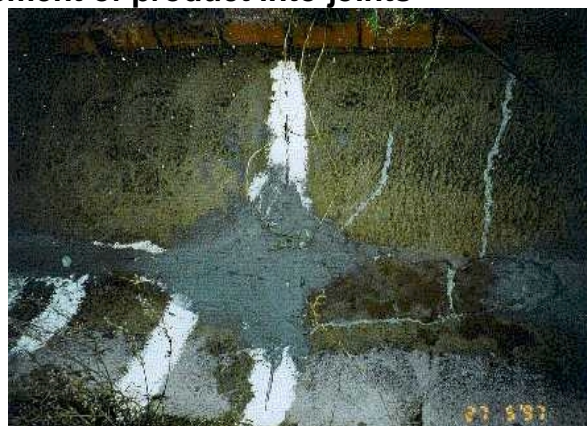
The rapid setting mortar was mixed with fresh water to form a paste of a suitable slurry consistency to bond to the surface as well as flow into the crevices of the joint. The amount of fresh water used depends on the proposed application and the insitu temperature/humidity.

Due to the rapid setting characteristics of the material only a few litres of product were mixed at one time. The product was spread over the joint using a gloved hand, ensuring that it was also allowed to run/pushed well into the exposed joints/cracks.

Figures 4 and 5 -Hand placement of product into joints

The surface being treated was always moist and the product was maintained in a slightly moist state after application to retard the setting process. Small hairline cracks have formed when the material is not moistened after application.

The product is dry to touch in approximately 5 minutes and the channel was returned to service 10 minutes after the application.
