REPAIR/REPLACEMENT OPTIONS FOR CONCRETE LINED IRRIGATION CHANNELS

CASE STUDY

JOINT REPAIR WITH XYPEX SPRAY MEMBRANE

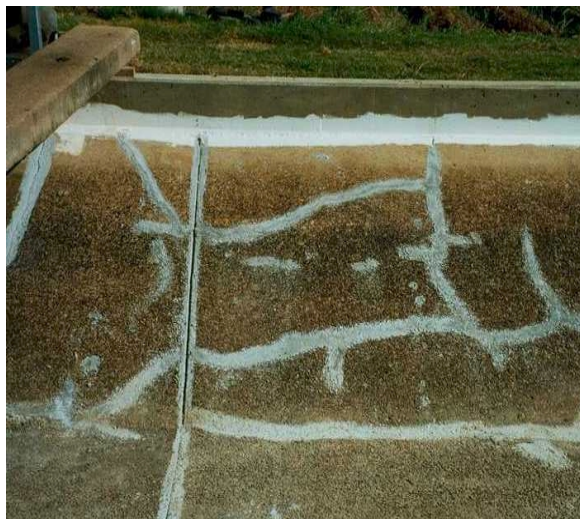
FIGURE 1

Cracks in the lining surface which were greater than 2mm were repaired (see Figure 1) using a putty type Xypex product, "Patch 'n' Plug". This malleable material is pushed into cracks by hand, which has proven to be the most labour intensive part of this repair option. Hair-Line cracks were not treated in this way as it would have proven impractical and they are adequately sealed by the sealant and waterproofing steps.

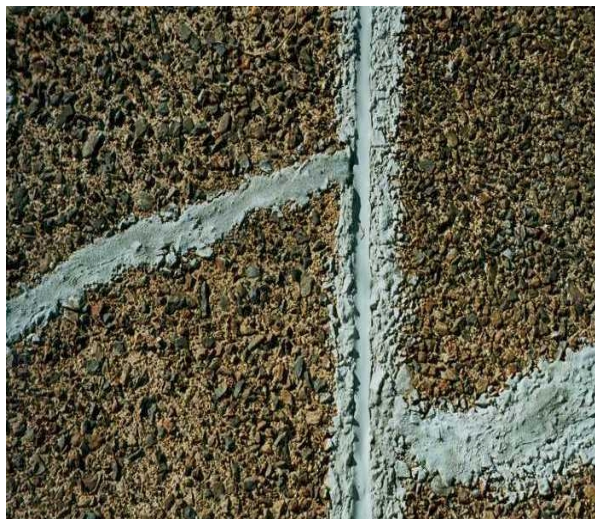
FIGURE 2

The sealing agent was then placed into all excavated joints (see Figure 2), ensuring that the cavity was thoroughly filled and that the material was struck off flush with the surface of the channel.

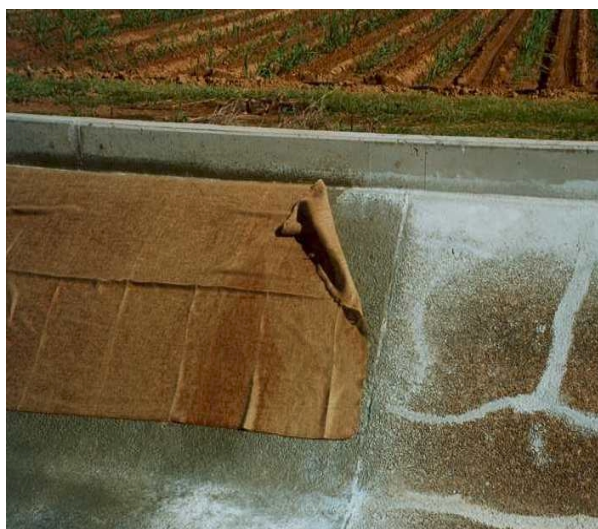
FIGURE 3

The surface was then coated with the waterproofing product, "Xypex Concentrate" (a powder mixed to the liquid state at a rate of 5 parts powder to 3 parts water) applied using a hopper gun spray method. This material is overcoated (as described in Step 5) as soon as it is firm to walk on and no longer than 24 hours unless kept moist.

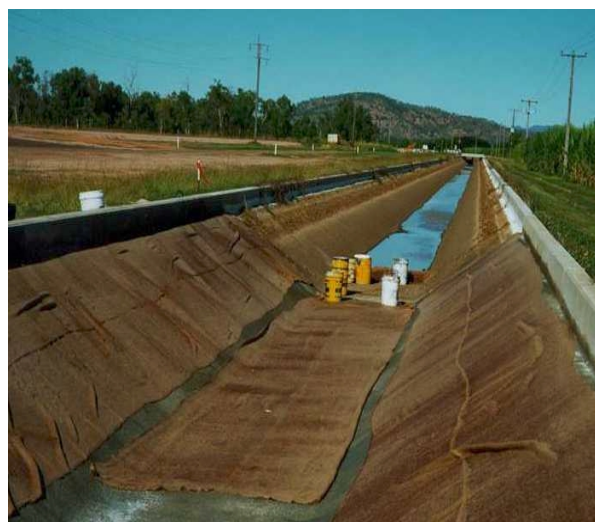
FIGURE 4

Once the “Xypex Concentrate” has cured a final coating of sand/cement and “Xypex Admixture” (at an approximate rate of six litres per m²) is placed over the material as a final sealing agent. The primary purpose of the “Xypex Admixture” is to retain moisture for the “Xypex Concentrate” so as to allow crystalline growth into the existing concrete structure to continue and to protect from external damage during this transition. A layer of wet hessian (see Figure 4) cloth is then layed over the material to aid in the curing process. This cloth was kept moist for 24 hours of the application.
