Watershed Torbay Catchment Restoration Plan

APRIL 2005

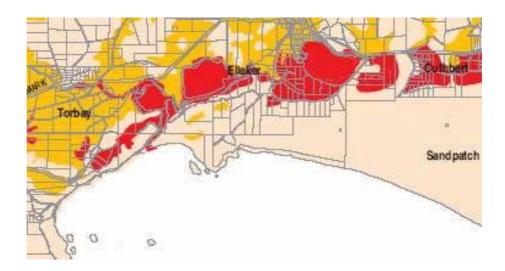
Figure A5, Distribution of Acid Sulphate Soils in the Lower Torbay Catchment

Low-lying areas in near-coastal parts of the Torbay catchment are underlain by estuarine and shallow marine silty and sandy sediments of Holocene age (i.e. sediments that formed since the last ice age within the last 10,000 years). These sediments contain significant amounts of the iron sulfide mineral pyrite and they are highly reactive when exposed to air. Excavation of these

materials can created acid sulfate soils and the risk of discharging acidity and metals into the drainage system. Acid sulfate soils were first identified at Ewarts Swamp where a horticultural scheme failed because drainage had exposed pyrite to the air causing acidified soil and groundwater (Woodward, 1917). The potential occurrence of acid sulfate soils is shown in Figure A5.

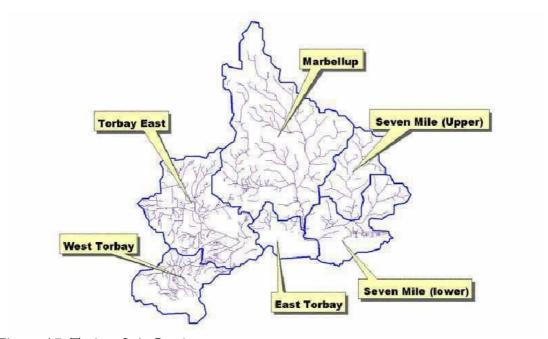
Figure A7, Torbay Sub-Catchments

The sub-catchments defined for use within the program area are shown in Figure A7.

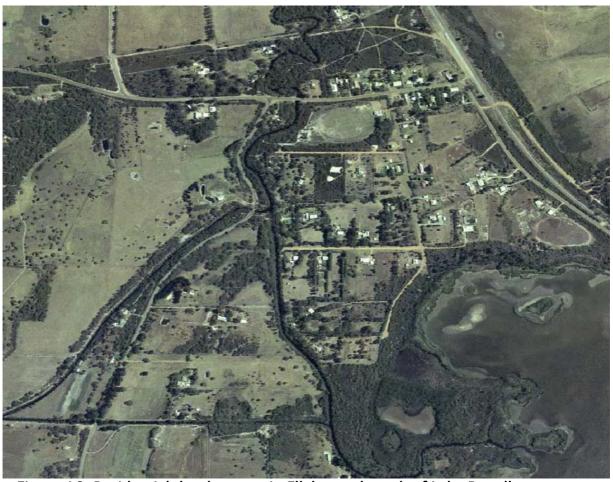
Figure A8. Residential development in Elleker and south of Lake Powell.

The revised scheme will provide for growth of Elleker subject to the preparation of a detailed townsite plan. Figure A8 illustrates the current residential areas of Elleker.
