# **Sustainable Stream Management in North-East Queensland:**

*Stabilisation for Rehabilitation*

**JAMES COOK UNIVERSITY**

**Land & Water  
Resources  
Research &  
Development  
Corporation**

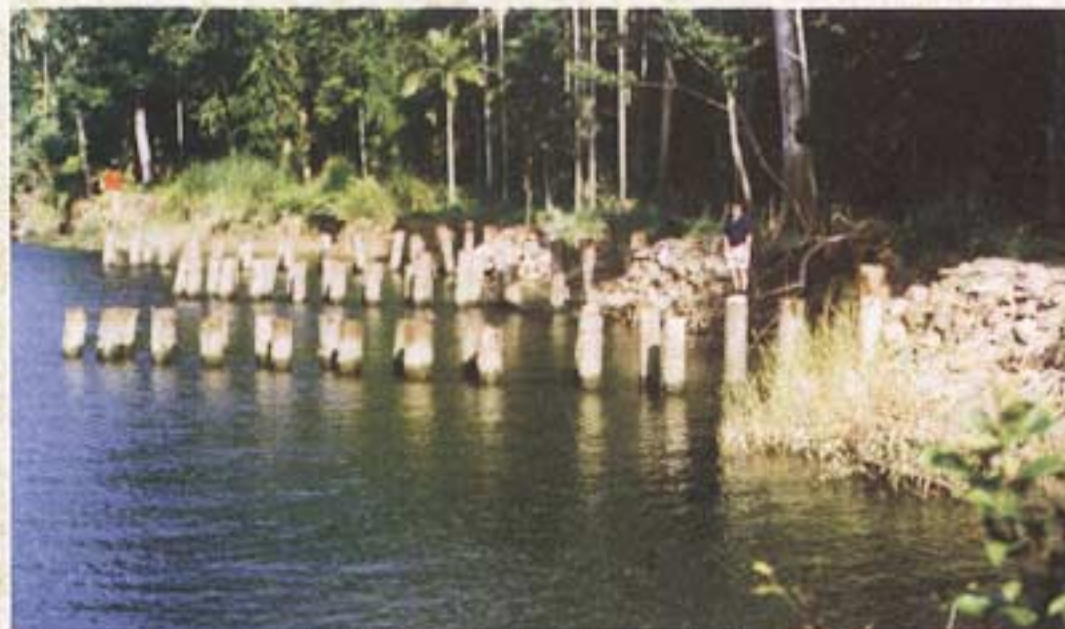
*Pile groynes on the Mulgrave River*
