Repair/Replacement of Concrete Lined Irrigation Channels

Case Study Geomembrane Lining

Mareeba Dimbullah Irrigation Area
State Water Projects, Queensland

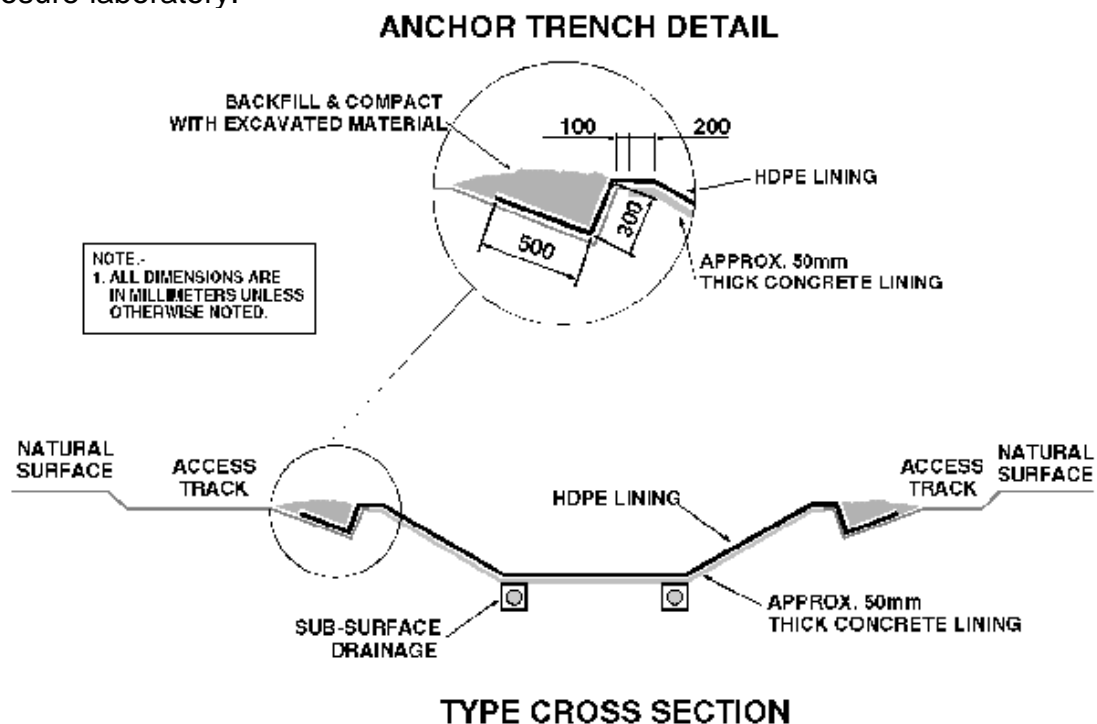
About twelve months prior to the start of this project, a 400m section of smaller channel in a different location was lined with 2mm thick HDPE lining as a trial. This had followed a 10 year accelerated weathering test under tensile load at the Allunga exposure laboratory.

The existing concrete lining was retained as a foundation for the plastic liner. This trial section is now 2 years old and is performing well. Although 2 years is insufficient time to comment on UV exposure performance, the installation process went well. The trial section was quite small (1090m²) and was relatively expensive at about \$24/m².
